# Manhole Inspection Summary

Manhole # S35QQ\_016MH

Insp Date: 1/23/07 1:27 PM

**Location** Address: **2500 GUILFORD AVE**

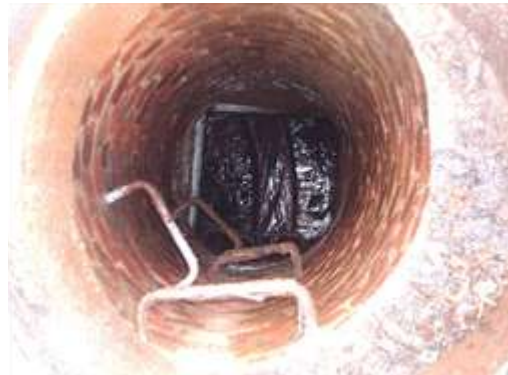
Top View

☐ Parged ☒ **Debris** (not Condition related)

Count: **7** Missing: **0** ☒ **Corroded**

Corroded steps. Bench debris.

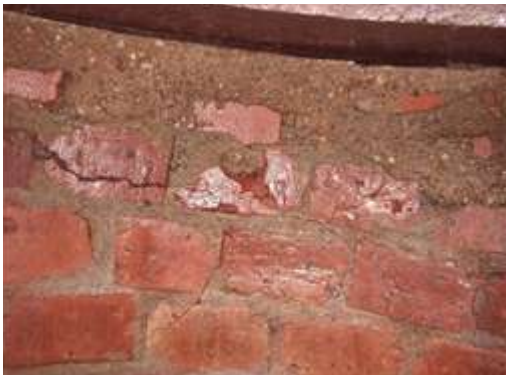
Defect

Corbel cracks.

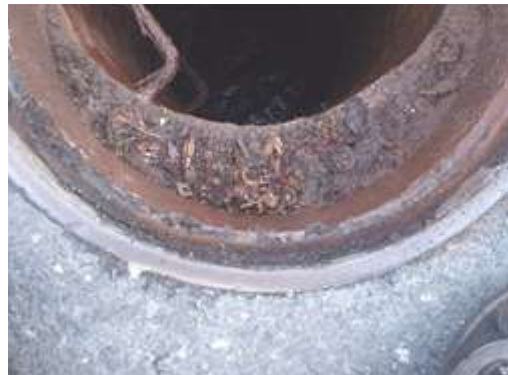
Defect

Frame leaks. Frame offset. Adjustment infiltration.

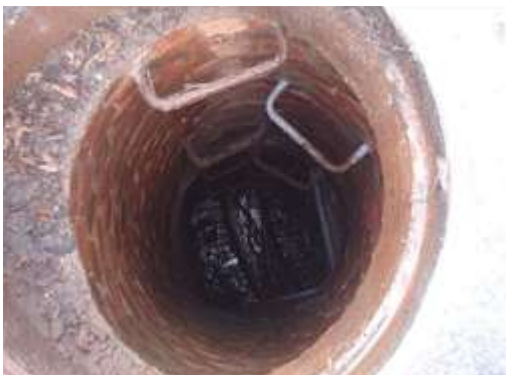
Defect

Infiltration: ☐ None ☐ Joint ☐ Cracks ☐ Mortar ☐ Roots ☒ **Wall**

Frame leaks. Frame offset. Adjustment and Barrel infiltration.

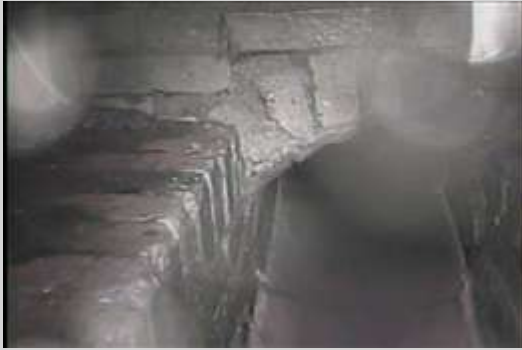
### 12 in. Circular Gravity Sewer

Deposits: ☐ None ☐ Mud ☐ Sludge ☐ Debris ☒ Grease

Silt Depth: **0** (in.) Deposits Extent: **Light**

Infiltration: **None** Pipe Seal Cond: **Broken**

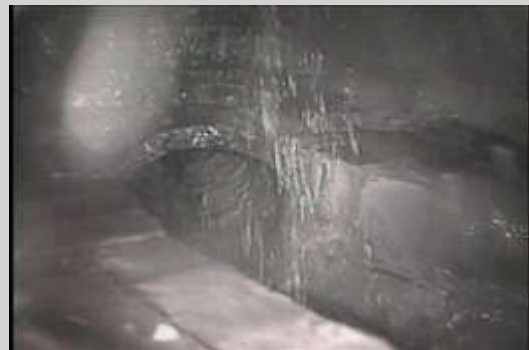
Drop In @ 9 O'Clock

Drop: **Outside** Rod and Bar  
Angled: **Yes** Reading: **12.55** (ft.)  
Inv Depth: **13.55** (ft.)  
Drop Condition: **Partly Clogged**
